EEK HEALTH CLINIC

Alaska Rural Primary Care Facility Code and Condition Survey

April 23, 2003

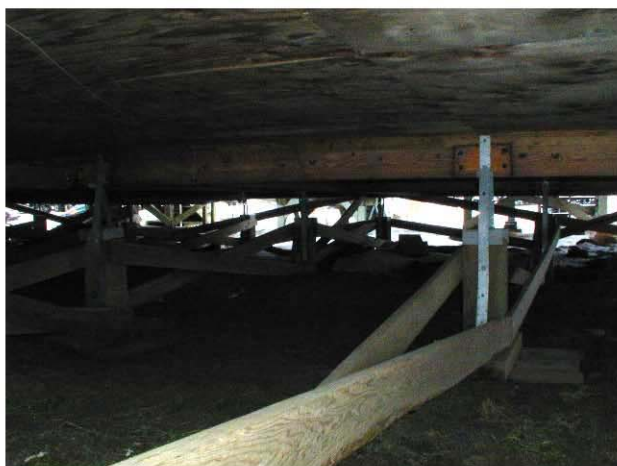
Foundation

The foundation is post and pad with adjustment devices over a gravel pad and is in poor structural condition. Pads have settled, walls are racked, and the building has floor level deviation and has substantial cracking on the interior. There not adequate hold down strapping and the bracing is loose or missing. In general the foundation needs substantial upgrade to new useful life or replacement.

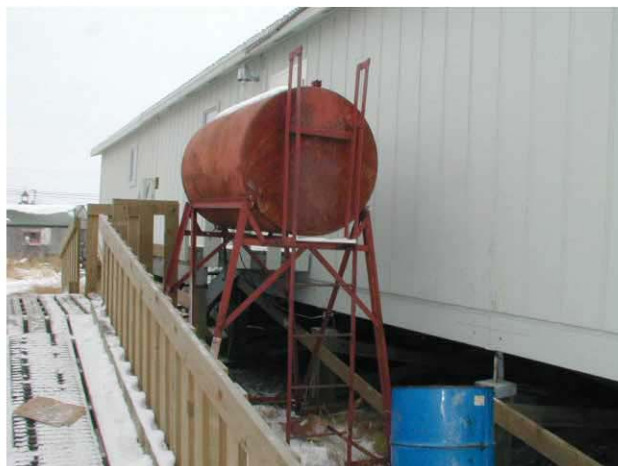
- d. Telephone
A single phone line services the clinic and is inadequate for current needs.
 - e. Fuel Oil
The fuel system is not adequate with some leaking having occurred around the existing above ground tank. There is not protection or containment for possible spilling.

The clinic's heating fuel oil storage tank is located adjacent to the building and not a minimum of 5 ft. as required by code. The 225-gallon storage tank does not have the proper venting, piping, or valving as required by code. Severe corrosion on the tank necessitates replacement.

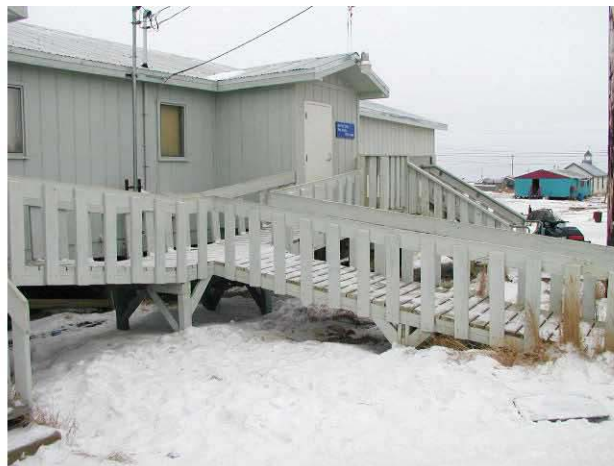
Front Ramp

There are minimal Arctic entries. The landing at the exterior door is deteriorating, and the stairs rise and run do not meet code. The ramp is very steep and does not meet ADA and the handrails and landings do not meet code. The facility requires all new stairs, ramps, railings and landings.

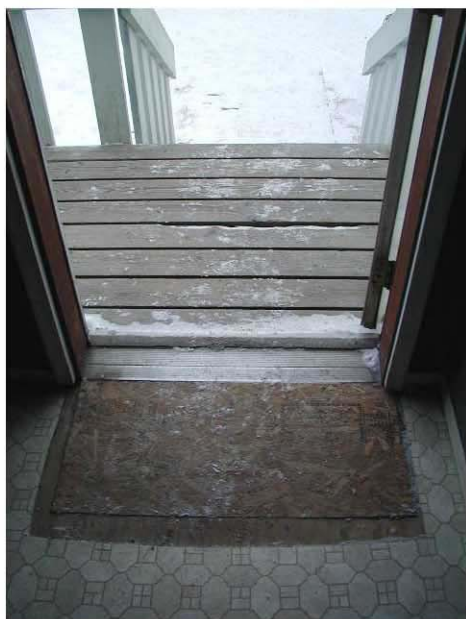
Entry

- a. Vestibule and comfort:
The front door of the clinic is through a non-compliant, unheated, vestibule, which is inadequate to defer the heat loss. There is no ADA access or proper gurney access. The exam rooms are cold every time the door is opened and the cold air migrates into the clinic where patients are being attended.

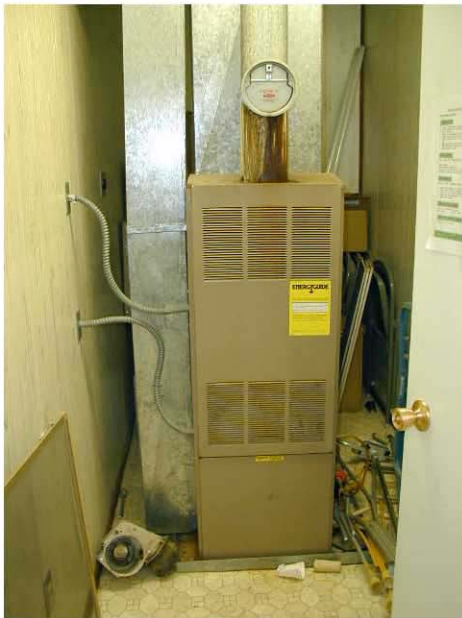
Furnace

- k. Mechanical/Boiler room – The room is a small room for the furnace and systems. The access is not separated from the rest of the facility. The furnace is in very poor shape and all of the heating system is in poor condition. There is not the required clearance to combustibles (entry door swing) or space as required by code

A single residential grade, oil-fired boiler provides heating for the entire clinic. The boiler is in fair condition with missing controls and systems that are required by code. There are combustion air openings for the boiler, but they are too small which is against code. There are no additional heaters in the clinic to assist with heating.

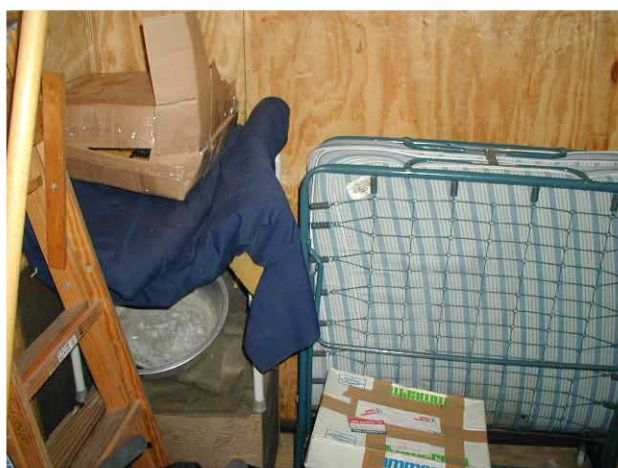
- i. Storage – Storage is inadequate and is an impediment to safety and the operation of this clinic. There is a lack of adequate storage for needed medical supplies, files, and equipment in this facility. There is minimal storage and mostly it is in the exam rooms. There is storage in rear entry, janitors, and mechanical rooms.
